# Breast phantom with silicone implant for evaluation in conventional mammography

JOURNAL OF APPLIED CLINICAL MEDICAL PHYSICS, v.12, n.1, p.199-206, 2011

Fábio A. R. Silva,<sup>1a</sup> Lúzia F Souza,<sup>1</sup> Carlos E. G. Salmon,<sup>2</sup>

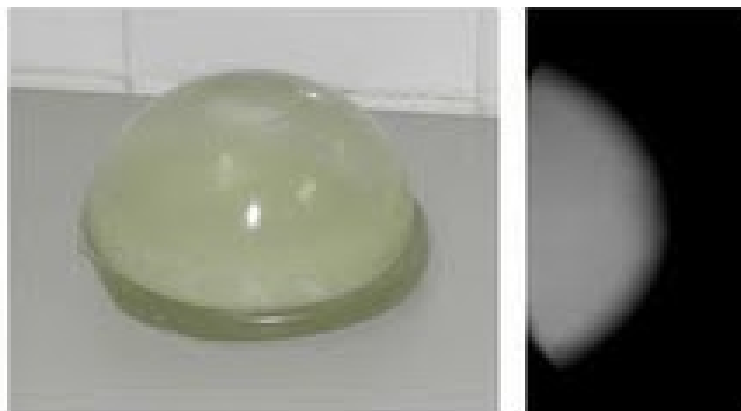
FIG. 1. The sample with base material and its mammographic image.

Figure 1, on the left, shows an image of the phantom which only contained the base material, and on the right, a mammogram obtained from this phantom. The mammographic image presents an optical background density of 1.46 OD.

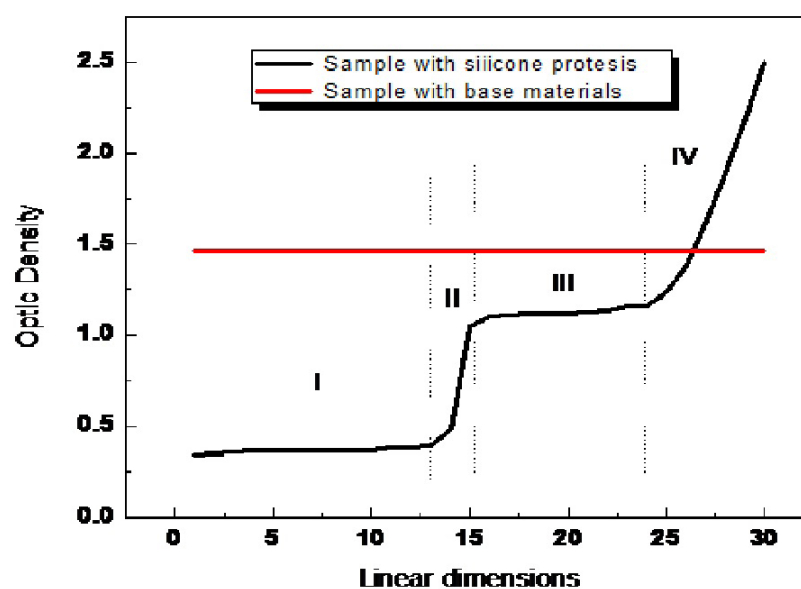
FIG. 2. Behavior in terms of optical density measured in sample with silicone prosthesis and sample with base material alone.

Figure 2 shows the behavior of optical density as a linear fit from the image corresponding to the sample that only contained the base material and which simulated breast tissue, and from the image corresponding to the sample in which the prosthesis was inserted into the base material. Differences in optical densities caused by X-ray beam interactions in the sample containing the prosthesis can be explained by describing the four regions observed in this mammogram. The first region (region I) is the region which corresponds to a sharp reduction in optical density due to the material of the implant. A transition region can be observed between the prosthesis and the material that simulated the breast tissue (region II). In the third region (region III), a gradient of optical density was found between the prosthesis and the outer limits of the base material. In this band the optical density was reduced from 1.45 to 1.12 on average, a reduction of 23% in the power of breast tissue visualization. In the last region (region IV), the darkest part of the film is observed on the direct exposition. In Fig. 3 we can see the intense brightness caused by the interaction of radiation on the silicone breast implant.

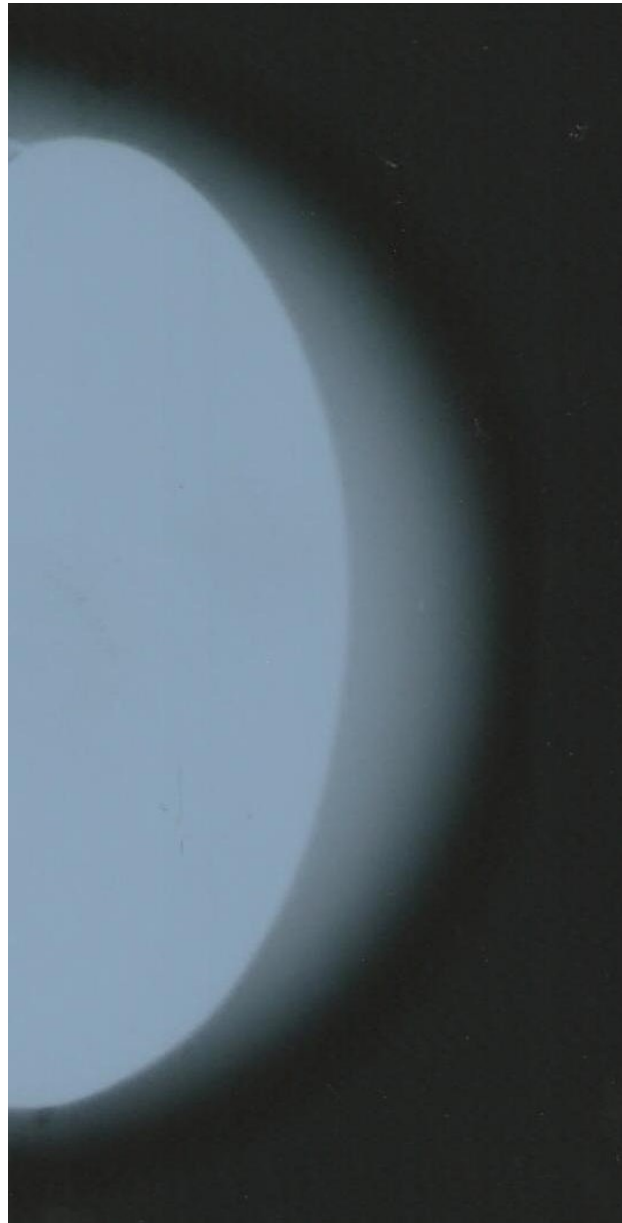
FIG. 3. Image of the phantom containing only the base material and the silicone breast implant.

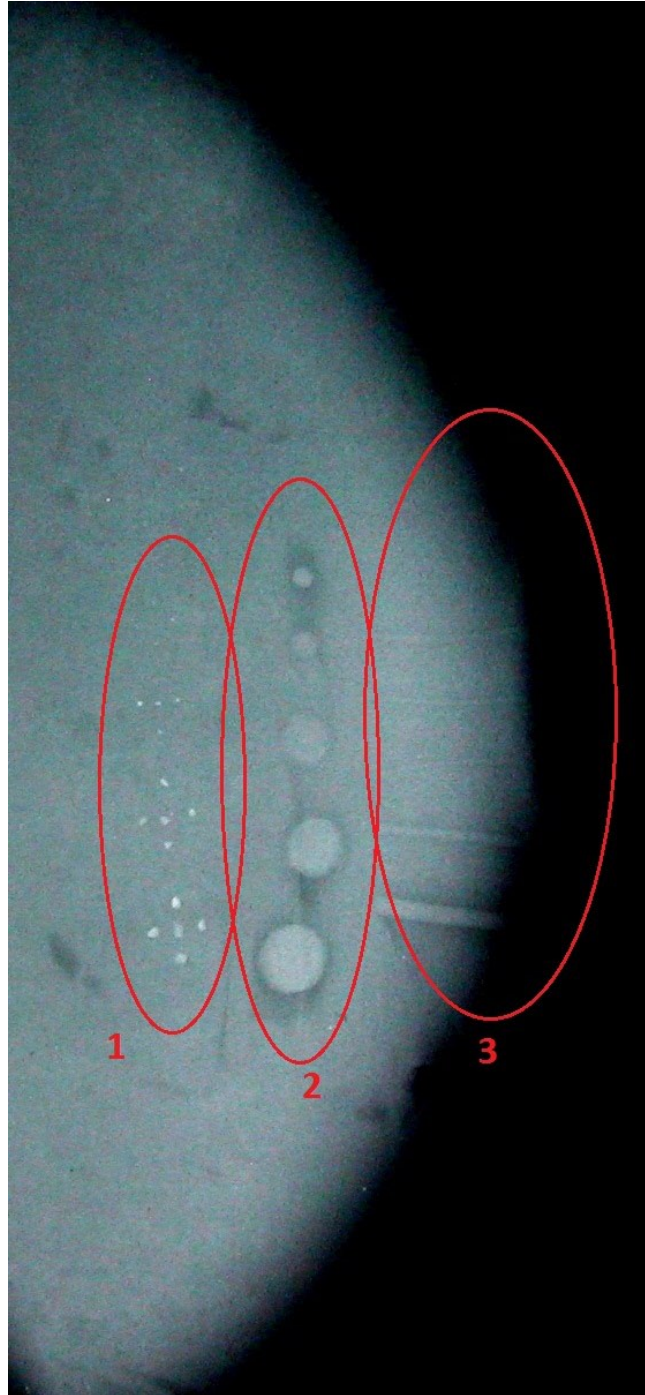
FIG. 4. Image of the base material containing inserted artifacts: microcalcifications (detail 1), tumor masses (detail 2) and fibers (detail 3).

An image of the phantom sample containing the artifacts can be seen in Fig. 4. These artifacts were used to simulate the main mammographic findings and include: four sets of microcalcifications, five tumor-like masses and five fibers. However, it was only possible to visualize three sets of microcalcifications (detail 1), five tumor masses (detail 2), and four fibers (detail 3) in the image of this phantom sample.

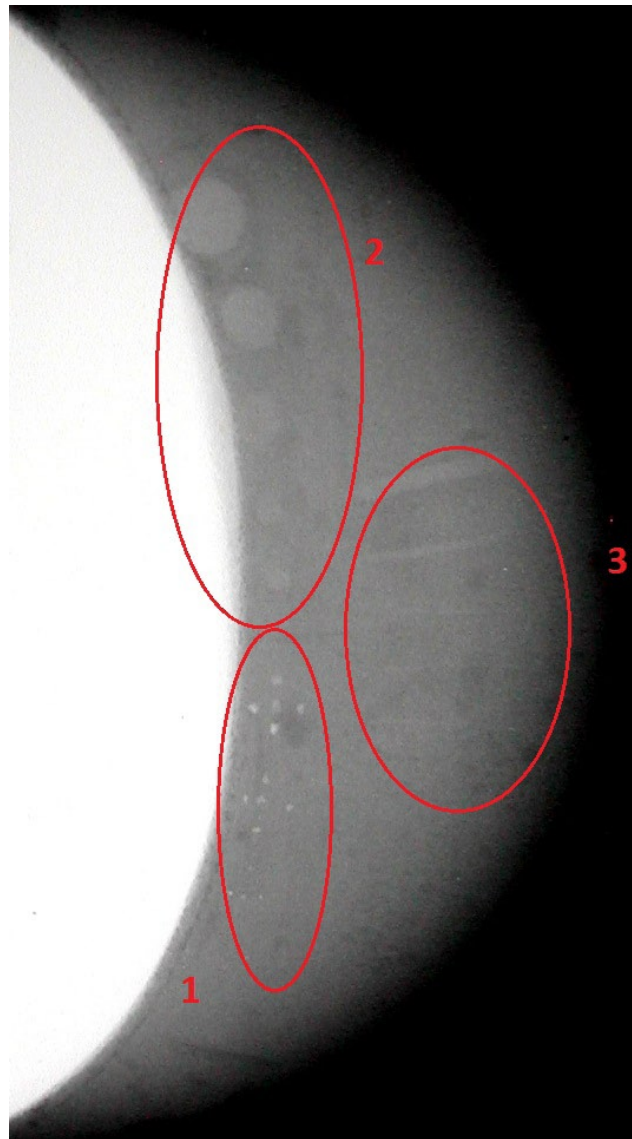
FIG. 5. Image of the proposed phantom containing the silicone implant and the inserted artifacts: microcalcifications (detail 1), tumor masses (detail 2) and fibers (detail 3).

Figure 5 shows the fourth phantom image containing both the prosthesis and the artifacts which simulated the main mammographic findings. The display of the test structures suffered a loss in sharpness because of the scattering of radiation within the prosthesis. Compared to Fig. 3, the number of artifacts that could be seen were reduced; only two sets of microcalcifications (detail 1), four tumor-like masses (detail 2), and two fibers (detail 3).
